**CONDITION ASSESSMENT OF MEDIUM-POWER TRANSFORMERS
USING DIAGNOSTIC METHODS: PDC, FDS, FRA TO SUPPORT DECISION
TO MODERNIZE OR REPLACE SERVICE-AGED UNITS**

R. MALEWSKI* J. SUBOCZ M. SZROT, J. PŁOWUCHA, R. ZALESKI
Instytut Elektrotechniki Politechnika Szczecińska Energo-Complex
Poland

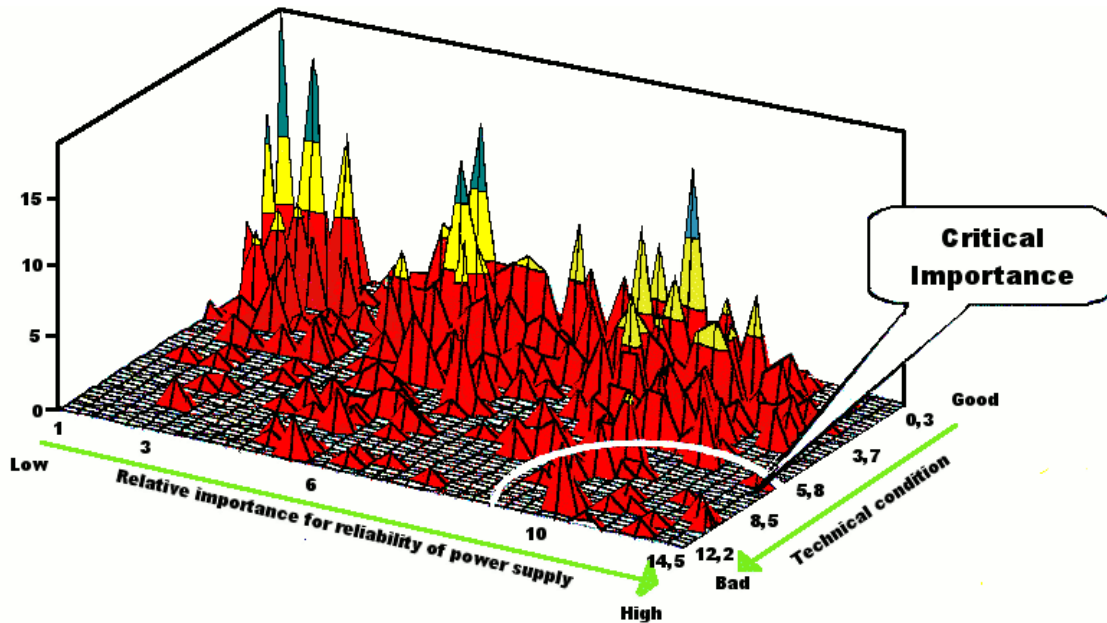
Fig. 3. (After [2, 3]). An example of 900 transformers with their relative importance for system reliability plotted against the transformer technical condition. Such graph forms the base of a ranking list of transformers to be modernized or replaced.

A rational planning of investments requires a ranking list of transformers to be modernized or replaced. Relative importance of each transformer for system reliability, and the transformer technical condition is shown in Fig.3 [2, 3]. Besides, operational costs have to be considered, although some utilities prefer to keep older transformers in service despite their high loss and costly maintenance, just to postpone investment in modernization or replacement.
