A2-209

CIGRE 2008

CONDITION ASSESSMENT OF MEDIUM-POWER TRANSFORMERS USING DIAGNOSTIC METHODS: PDC, FDS, FRA TO SUPPORT DECISION TO MODERNIZE OR REPLACE SERVICE-AGED UNITS

R. MALEWSKI* J. SUBOCZ M. SZROT, J. PŁOWUCHA, R. ZALESKI Instytut Elektrotechniki Politechnika Szczecińska Energo-Complex

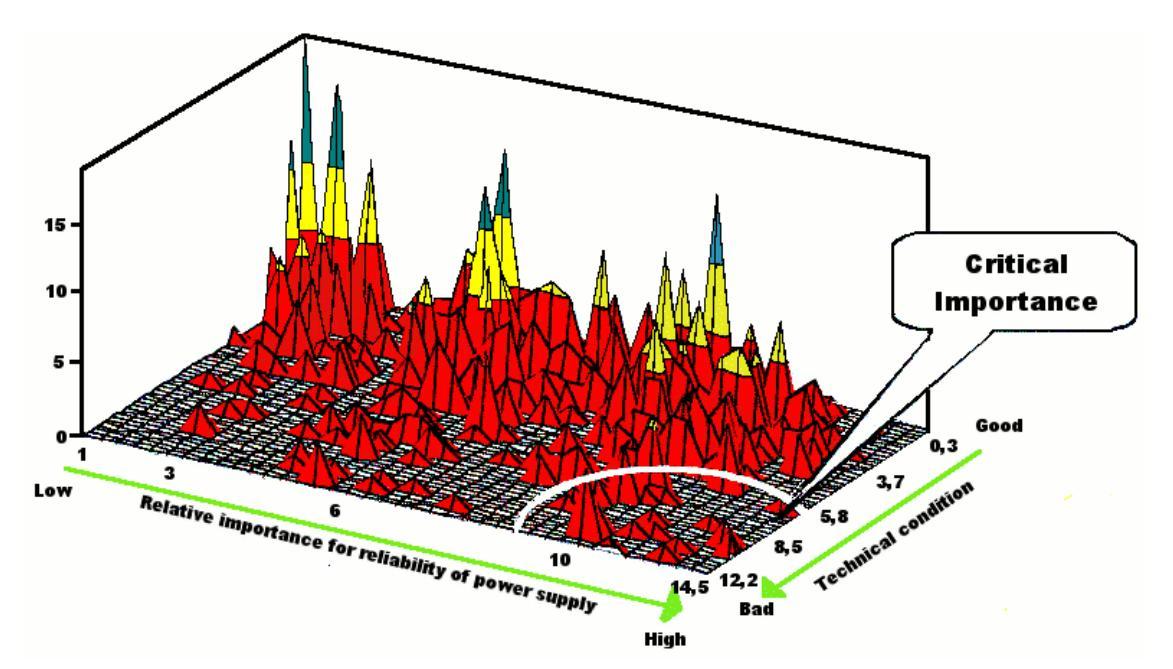
Fig. 3. (After [2, 3]). An example of 900 transformers with their relative importance for system reliability plotted against the transformer technical condition. Such graph forms the base of a ranking list of transformers to be modernized or replaced.

A rational planning of investments requires a ranking list of transformers to be modernized or replaced. Relative importance of each transformer for system reliability, and the transformer technical condition is shown in Fig.3 [2, 3]. Besides, operational costs have to be considered, although some utilities prefer to keep older transformers in service despite their high loss and costly maintenance, just to postpone investment in modernization or replacement.

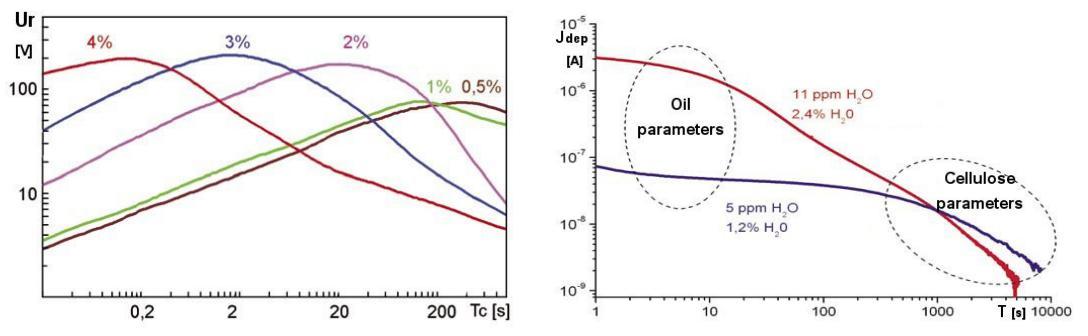
Fig. 4. Water content in cellulose [%] revealed by the Recovery Voltage curves for five different insulation samples – left graph. Water content in oil [ppm] and in cellulose [%] derived from Depolarization Current characteristic measured on insulation of two transformers – right graph.

Following this research project, our service company Energo-Complex,, in collaboration with Szczecin Technical University, has implemented RVM, PDC and FDS techniques to condition assessment of a large number of medium-power transformers. In practice, the owner of a medium-power transformer has to decide on insulation drying, or continued operation. For this purpose it is sufficient to state that water content in cellulose is less than 1%, 2% or 3%, since a more accurate value does not change the transformer owner decision. However, such condition assessment has to be confirmed by more than one diagnostic technique. A typical record of moisture in solid insulation obtained using RVM and PDC is shown in Fig. 4.

Polarization and depolarization current is recorded for couple of hours after application or shortcircuiting a direct voltage. Certain sections of this current decay characteristic reveal water content in oil and in cellulose. The characteristic is analyzed by decomposition into a straight line that reflects oil resistivity, and a few exponential components with different decay time-constants. These timeconstants, derived from for instance depolarization current plot, correspond to certain water content in cellulose. Again, this analysis requires reference values obtained by examination of cellulose samples with controlled and known water content. Once calibrated, the depolarization current plot provides water content in oil and in cellulose with accuracy sufficient for transformer condition assessment.

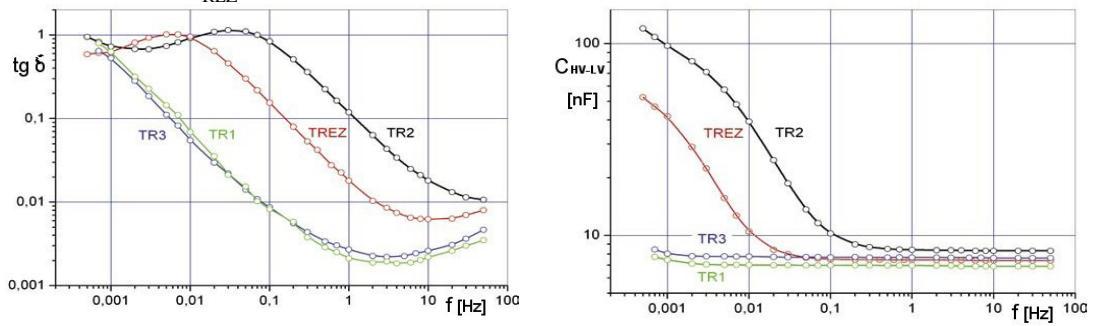
Fig. 5. Dielectric loss factor $tg\delta$ of main insulation of four GSU transformer plotted as a function of frequency from 0.6 mHz to 60 Hz (left graph). Capacitance of main insulation of the same transformers plotted in the same frequency range (right graph).

Frequency Domain Spectroscopy of paper-oil insulation yields the dielectric loss factor tg δ and capacitance frequency-characteristic in very low frequency range. To determine water content in solid insulation these characteristics are analyzed using X-Y model of barrier insulation between the high and low voltage winding [8]. Reference characteristics derived from controlled moisture-content cellulose-samples are required to calibrate the model. Water content in the main insulation of three GSU transformers rated at 75 MVA, 115/10.5 kV is as follows: TR1 – 1.2%, TR2 – 3.2%, TR3 – 1.4% and the reserve unit T_{REZ} – 3.1%. A quick, visual inspection of characteristics shown in Fig. 5 reveals a marked difference between the dry insulation of TR1 and TR3, as compared to rather wet cellulose insulation of TR2 and T_{REZ}.

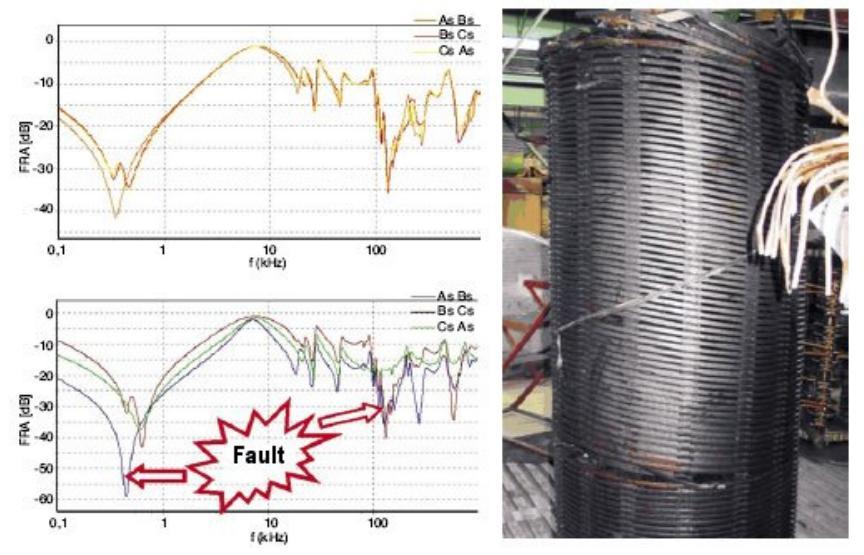
Fig. 6. Frequency response of HV winding of 25 MVA, 115/6.6 kV transformer recorded before (upper graph) and after deformation of this winding by heavy short-circuit current (lower graph).

Polish engineers Lech and Tyminski [9] have been first to reveal the winding displacement in transformers in service. They recorded the winding response to a repetitive steep-front low-voltage impulse, and compared records taken on three-phase windings. The comparison of winding response presented as a function of frequency, rather than time [10], has facilitated interpretation of the recorded characteristics.

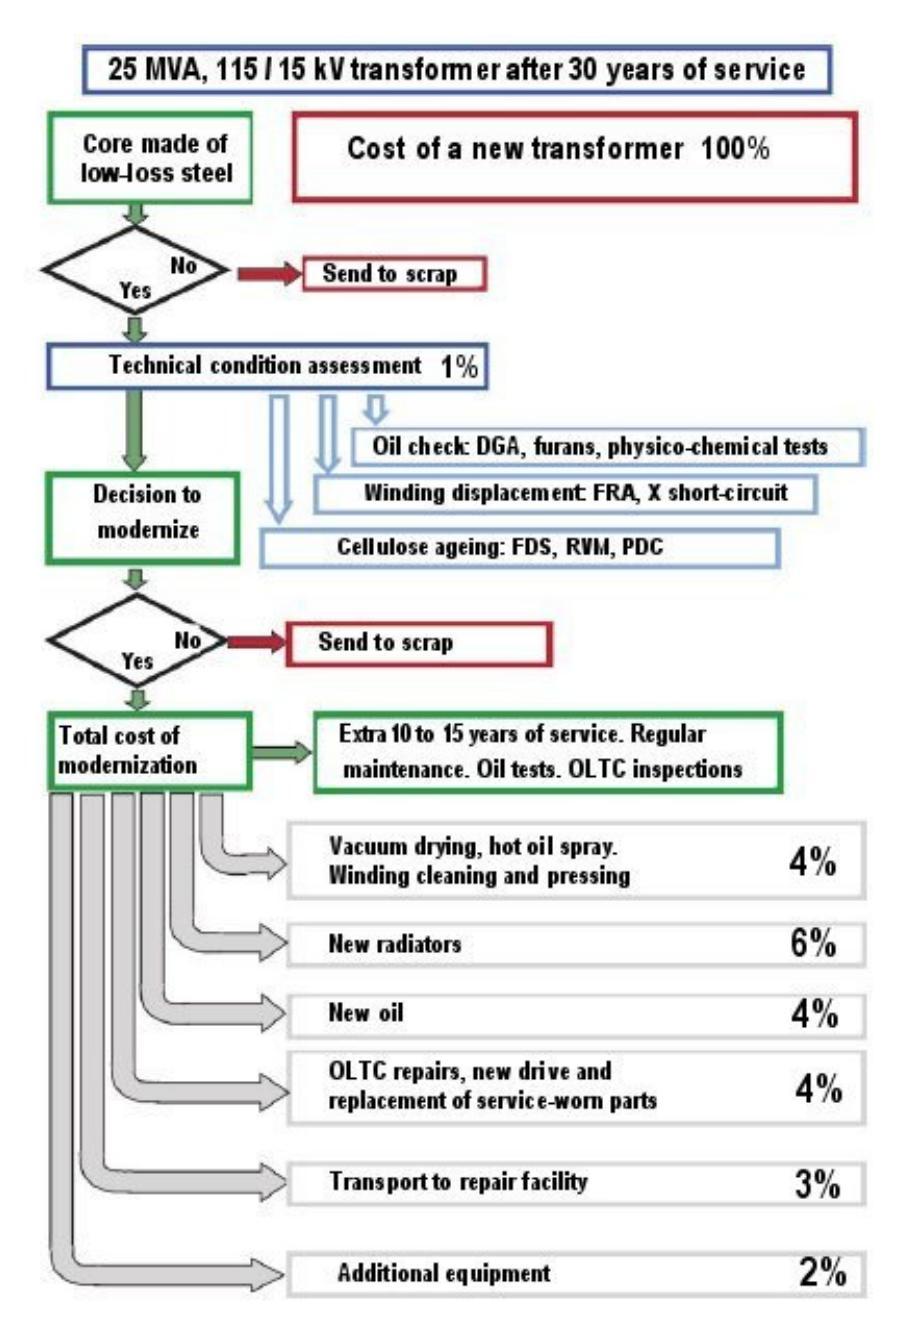
Fig. 7. Core loss evaluation, assessment of winding integrity and cellulose ageing are required to take a decision on sending an older transformer to a repair facility or to scrap. Cost of components and labor involved in modernization of a typical medium-power transformer at a repair facility amounts to 24% of the new transformer cost, including the cost of condition assessment.

Modernization of an older transformer is economically justified if the cost of drying, cleaning and pressing of the windings, replacement of radiators, filling transformer with new oil, overhaul of OLTC, and transport to the repair facility represents an acceptable fraction of the new transformer cost. The modernized unit may serve for another 10 to 15 years, and the investment in the new transformer is postponed. With the sharply increased price of transformer steel and copper, cost of a new unit represents a substantially larger expenditure than modernization that preserves at least the core, windings and tank. The cost of condition assessment is negligible in comparison to the cost of modernization, which is presented in Fig. 7 for a typical transformer rated at 25 MVA, 115/15 kV.
