**CONDITION ASSESSMENT OF MEDIUM-POWER TRANSFORMERS
USING DIAGNOSTIC METHODS: PDC, FDS, FRA TO SUPPORT DECISION
TO MODERNIZE OR REPLACE SERVICE-AGED UNITS**

R. MALEWSKI* **J. SUBOCZ** **M. SZROT, J. PŁOWUCHA, R. ZALESKI**
Instytut Elektrotechniki Politechnika Szczecińska **Energo-Complex**
Poland

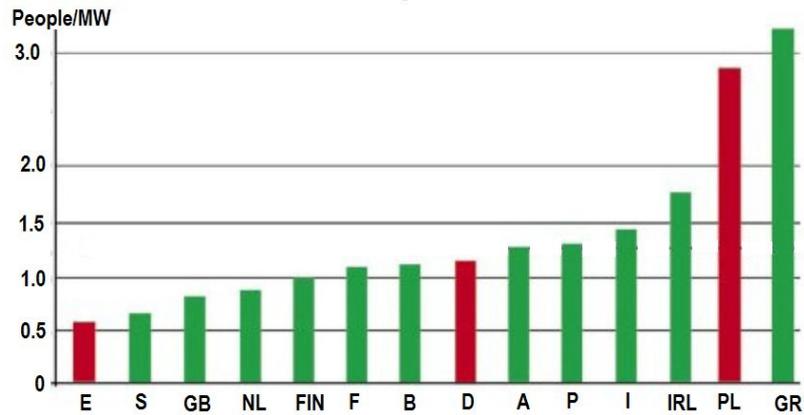
Fig. 1. (After [1]). Employment for 1 MW of installed power in EU countries.

Despite a relatively larger number of employees in Polish distribution companies, power failures are more frequent than in majority of European Union countries, as it is shown in Fig.1 and Fig.2. Inevitably, Polish utilities will have to reduce the number of employees, and at the same time to improve reliability of power delivery in the forthcoming years. Free, competitive energy-market forces these utilities to postpone major investments and to keep existing assets in operation as long as possible. Transformers are the most expensive elements of distribution network, and replacement of service-aged units is dictated by two factors: their critical importance to reliability of power delivery, and their technical condition.

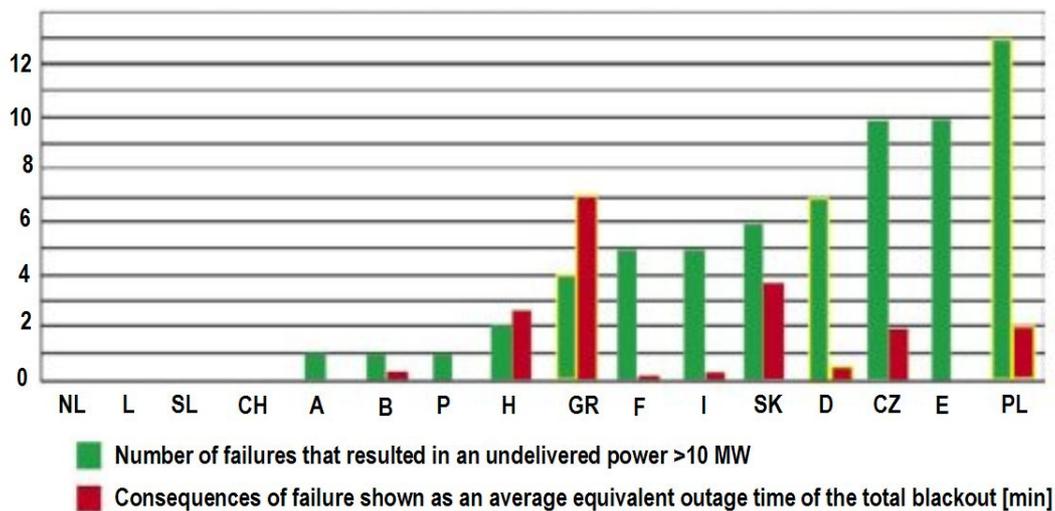
Fig. 2. (After [1]). Number of outages that caused a loss of delivered power >10 MW, and an equivalent time of their duration, in EU countries.

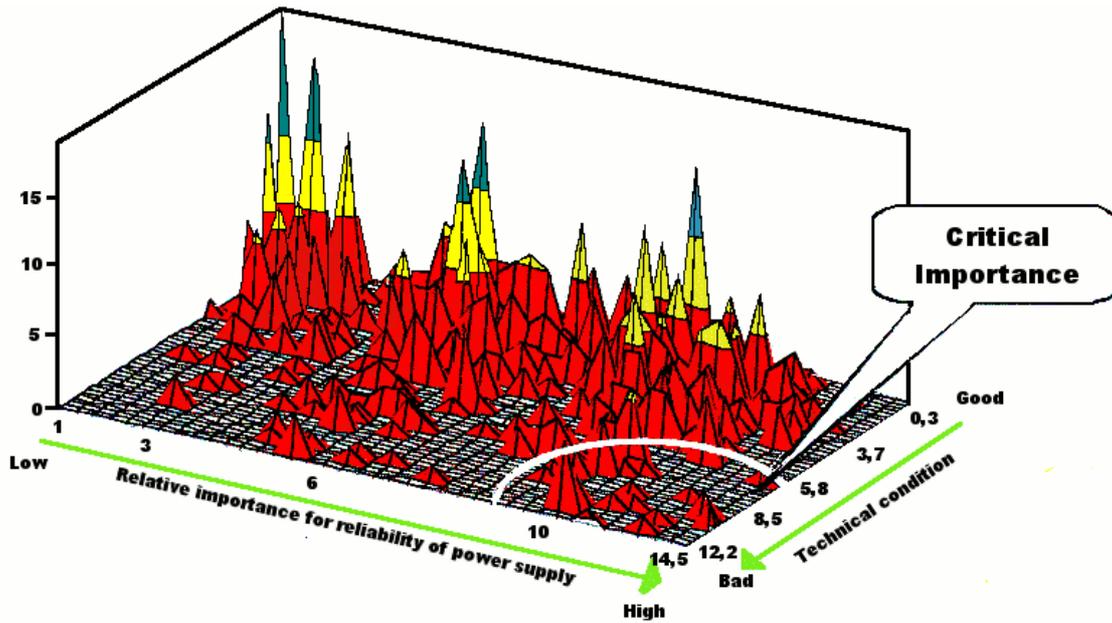
Fig. 3. (After [2, 3]). An example of 900 transformers with their relative importance for system reliability plotted against the transformer technical condition. Such graph forms the base of a ranking list of transformers to be modernized or replaced.

A rational planning of investments requires a ranking list of transformers to be modernized or replaced. Relative importance of each transformer for system reliability, and the transformer technical condition is shown in Fig.3 [2, 3]. Besides, operational costs have to be considered, although some utilities prefer to keep older transformers in service despite their high loss and costly maintenance, just to postpone investment in modernization or replacement.

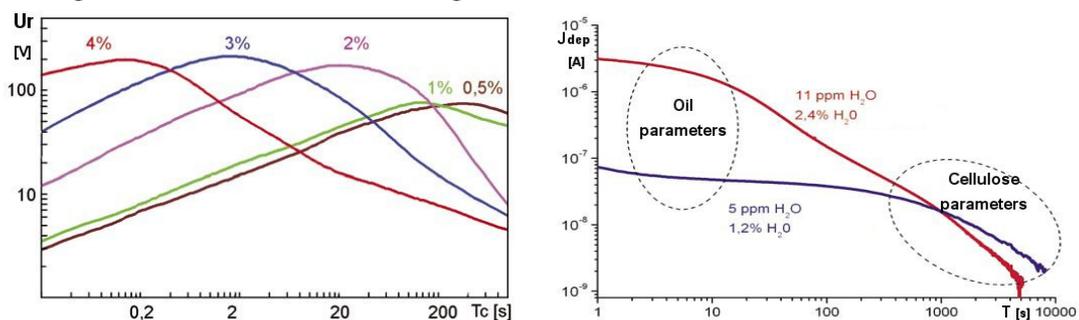
Fig. 4. Water content in cellulose [%] revealed by the Recovery Voltage curves for five different insulation samples – left graph. Water content in oil [ppm] and in cellulose [%] derived from Depolarization Current characteristic measured on insulation of two transformers – right graph.

Following this research project, our service company Energo-Complex., in collaboration with Szczecin Technical University, has implemented RVM, PDC and FDS techniques to condition assessment of a large number of medium-power transformers. In practice, the owner of a medium-power transformer has to decide on insulation drying, or continued operation. For this purpose it is sufficient to state that water content in cellulose is less than 1%, 2% or 3%, since a more accurate value does not change the transformer owner decision. However, such condition assessment has to be confirmed by more than one diagnostic technique. A typical record of moisture in solid insulation obtained using RVM and PDC is shown in Fig. 4.

Polarization and depolarization current is recorded for couple of hours after application or short-circuiting a direct voltage. Certain sections of this current decay characteristic reveal water content in oil and in cellulose. The characteristic is analyzed by decomposition into a straight line that reflects oil resistivity, and a few exponential components with different decay time-constants. These time-constants, derived from for instance depolarization current plot, correspond to certain water content in cellulose. Again, this analysis requires reference values obtained by examination of cellulose samples with controlled and known water content. Once calibrated, the depolarization current plot provides water content in oil and in cellulose with accuracy sufficient for transformer condition assessment.

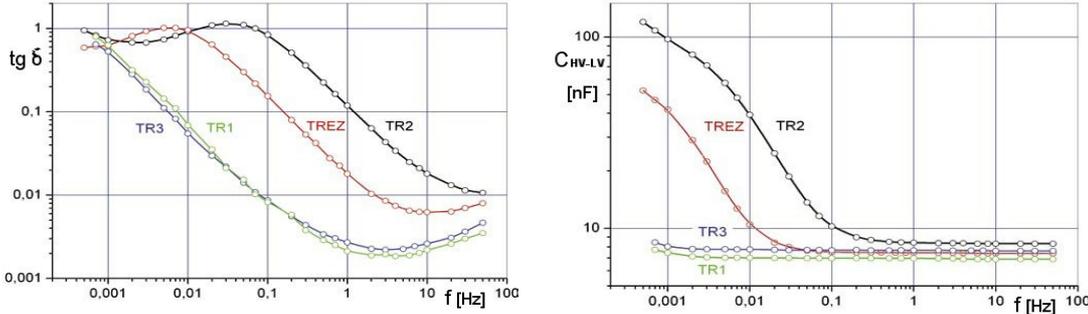
Fig. 5. Dielectric loss factor $\text{tg } \delta$ of main insulation of four GSU transformer plotted as a function of frequency from 0.6 mHz to 60 Hz (left graph). Capacitance of main insulation of the same transformers plotted in the same frequency range (right graph).

Frequency Domain Spectroscopy of paper-oil insulation yields the dielectric loss factor $\text{tg } \delta$ and capacitance frequency-characteristic in very low frequency range. To determine water content in solid insulation these characteristics are analyzed using X-Y model of barrier insulation between the high and low voltage winding [8]. Reference characteristics derived from controlled moisture-content cellulose-samples are required to calibrate the model. Water content in the main insulation of three GSU transformers rated at 75 MVA, 115/10.5 kV is as follows: TR1 – 1.2%, TR2 – 3.2%, TR3 – 1.4% and the reserve unit T_{REZ} – 3.1%. A quick, visual inspection of characteristics shown in Fig. 5 reveals a marked difference between the dry insulation of TR1 and TR3, as compared to rather wet cellulose insulation of TR2 and T_{REZ} .

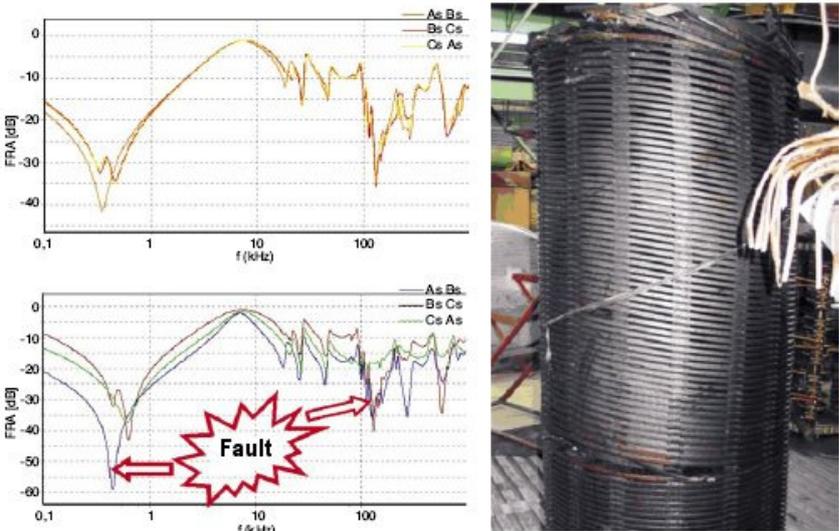
Fig. 6. Frequency response of HV winding of 25 MVA, 115/6.6 kV transformer recorded before (upper graph) and after deformation of this winding by heavy short-circuit current (lower graph).

Transformer windings have been designed to withstand the dynamic forces induced by short-circuit current in the network. The windings have been pressed in the factory, and the compression force was chosen to exceed the axial dynamic force and to prevent loose winding movement. However, the compressed cellulose has lost its initial elasticity during the years of service at high temperature, and the initial winding-compression has disappeared. Service-aged winding is then prone to coil displacement or deformation by the dynamic force, which is proportional to the square of short-circuit current magnitude. A small deformation does not always result in an immediate short-circuit, but a displacement of some coils decreases the oil-gaps size, crushes the brittle, service-aged paper insulation, and reduces the winding dielectric strength. Next lightning or switching over voltage may break such weakened insulation. A major failure of the transformer in service may develop, if the protection is not fast enough to clear the fault caused by an internal short-circuit inside the windings.

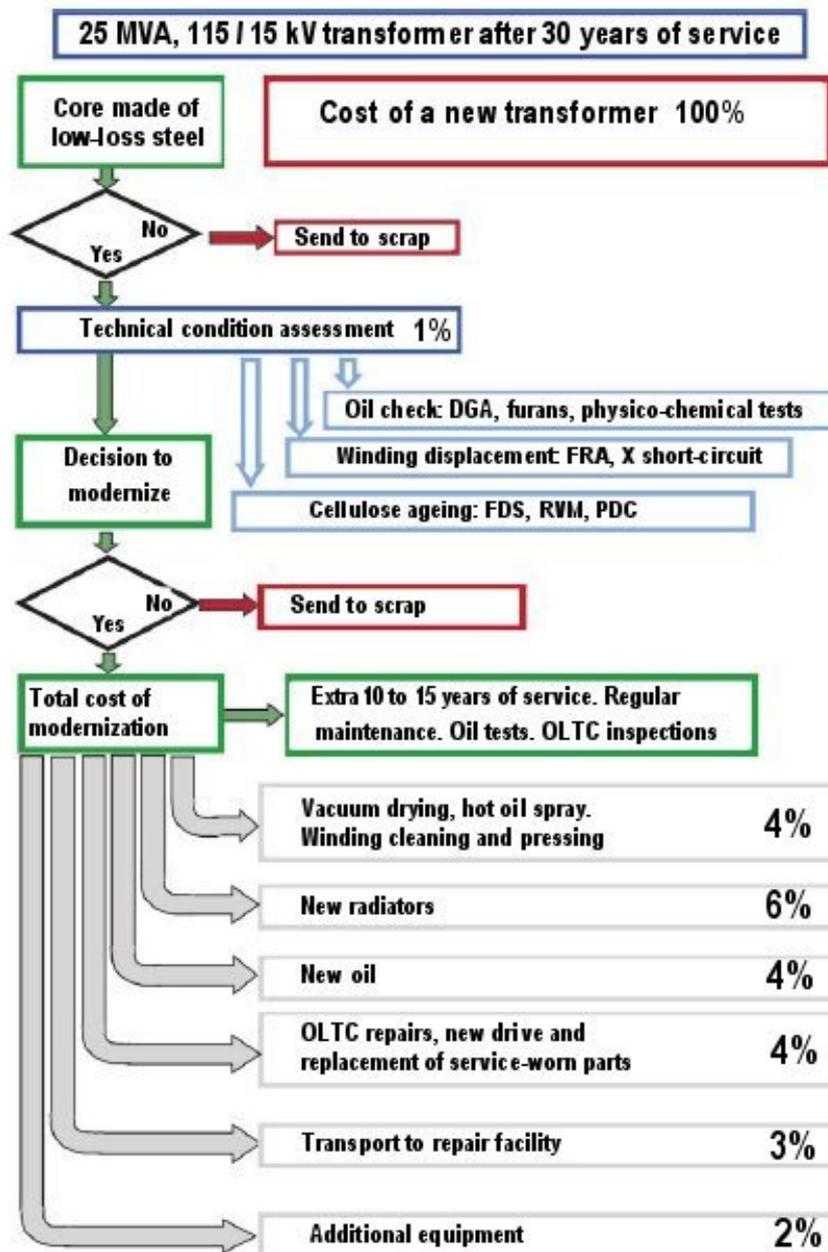
Fig. 7. Core loss evaluation, assessment of winding integrity and cellulose ageing are required to take a decision on sending an older transformer to a repair facility or to scrap. Cost of components and labor involved in modernization of a typical medium-power transformer at a repair facility amounts to 24% of the new transformer cost, including the cost of condition assessment.

Modernization of an older transformer is economically justified if the cost of drying, cleaning and pressing of the windings, replacement of radiators, filling transformer with new oil, overhaul of OLTC, and transport to the repair facility represents an acceptable fraction of the new transformer cost. The modernized unit may serve for another 10 to 15 years, and the investment in the new transformer is postponed. With the sharply increased price of transformer steel and copper, cost of a new unit represents a substantially larger expenditure than modernization that preserves at least the core, windings and tank. The cost of condition assessment is negligible in comparison to the cost of modernization, which is presented in Fig. 7 for a typical transformer rated at 25 MVA, 115/15 kV.
